WL-TR-92-4040

DURABILITY OF ADHESIVELY BONDED STRUCTURE

**Al E. Hohman
Charles M. Standard
LTV Aerospace and Defense Company
Missiles Division
P.O. Box 650003
Dallas, Texas 75265-0003**

Final Report for Period April 1991 - March 1992

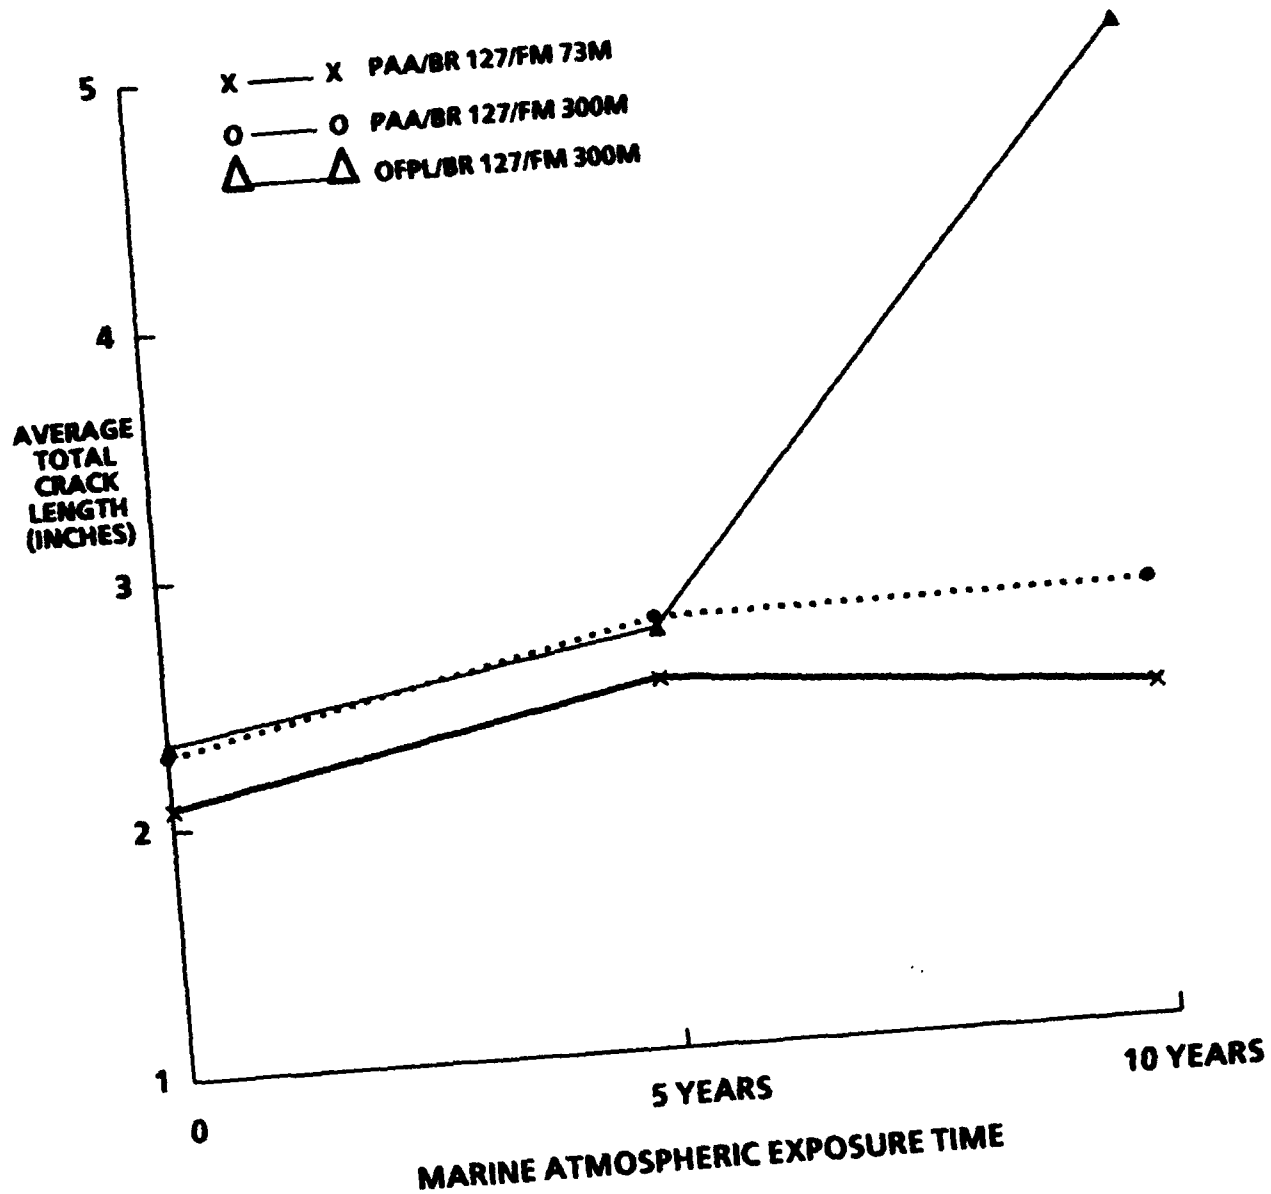
Figure 2: Crack Extension Specimens Total Length of Damaged Bond

Crack extensions for the three adhesive systems are shown in Table 3 and Figure 2. Table 4 shows the crack extension failure modes. Table 5, 6, and 7 show the lap shear strengths and modes of failure occurring after 5-year exposures for specimens exposed with no tensile load, 800 pounds and 1200 pounds nominal spring loads. Tables 8, 9, and 10 compile shear strengths over the 10-year exposure period.

Newly Bonded Specimens Tested in Laboratory		Specimens Tested for 5 Years in Sea-Side Environment		Specimens Tested for 10 Years in Sea-Side Environment		Specimens Aged for 10 Years in Sea-Side Environment Then Tested (2)	
	a	Δa (1)	a	Δa	a	Δa (5)	a	Δa
PAA/BR 127/ FM 73M (3)	2.09	0	2.16	.14	2.14	.20	2.18	.09
PAA/BR 127/ FM 300M (3)	2.40	.09	2.48	.25	2.48	.21	2.48	.05
OFPL/BR 127/ FM 300 (4)	2.32	.02	2.52	.23	2.51	1.89	2.75	.01

- (1) 81 Days in Laboratory Environment
 - (2) 24 Hours at 95% Relative Humidity
 - (3) 3 Specimens tested at each time interval
 - (4) 3 Specimens tested unexposed and after 5 years, and 2 specimens tested after 10 years aging
 - (5) Crack length does not include unseparated low adhesion areas
- a - Initial crack resulting from wedge insertion
 Δa - Crack extension resulting from environmental exposure

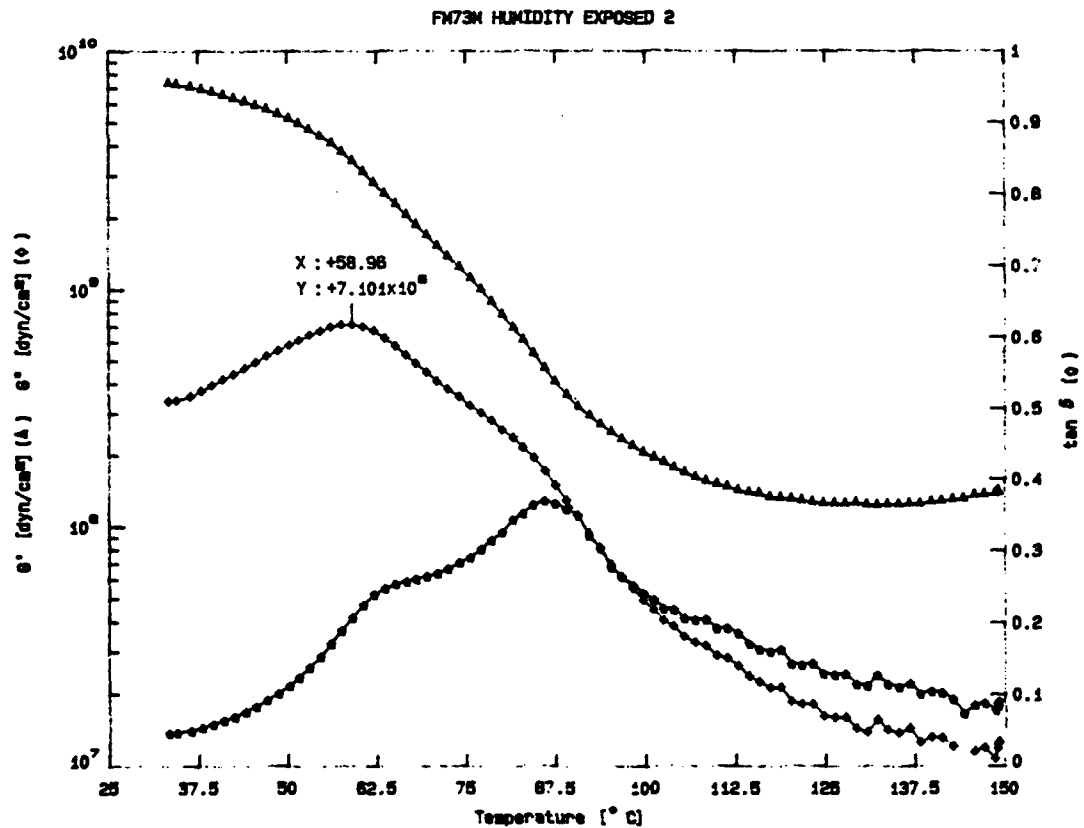
Figure 21: Moisture Conditioned FM 73M Elastic, Loss Modulus and Glass Transition

Initial reduction in strength is a result of moisture ingress into the primer and adhesive. This is shown by the wedge specimens in which the crack progresses as a cohesive failure to a lengthened crack after moisture conditioning. This shows the lower crack resistance within the adhesive to the constant stress in the wet condition. The crack generally remained as a cohesive separation in both adhesives, applied over phosphoric acid anodize (Figure 20). This reduction in strength is accompanied by a reduction in the modulus of elasticity as shown by the neat film measurements of torsional modulus in Figures 21, 22 and 23.

Rheological properties of the two adhesives in the "dry" and "wet" condition are shown in Figures 21 through 23. Both FM 73M and FM 300M show a broad peak in the G'' , loss modulus, demonstrating a significant elastomeric property throughout the ranges of measurement. The G' , modulus of elasticity, is reduced for both adhesives after moisture
